**BS5837 2012  
Trees in Relation  
To Design, Demolition and Construction**

**Tree Report**

**GE Aviation Site  
Hamble  
Southampton  
SO31 4NF**

**February 2018  
Revised August 2018**

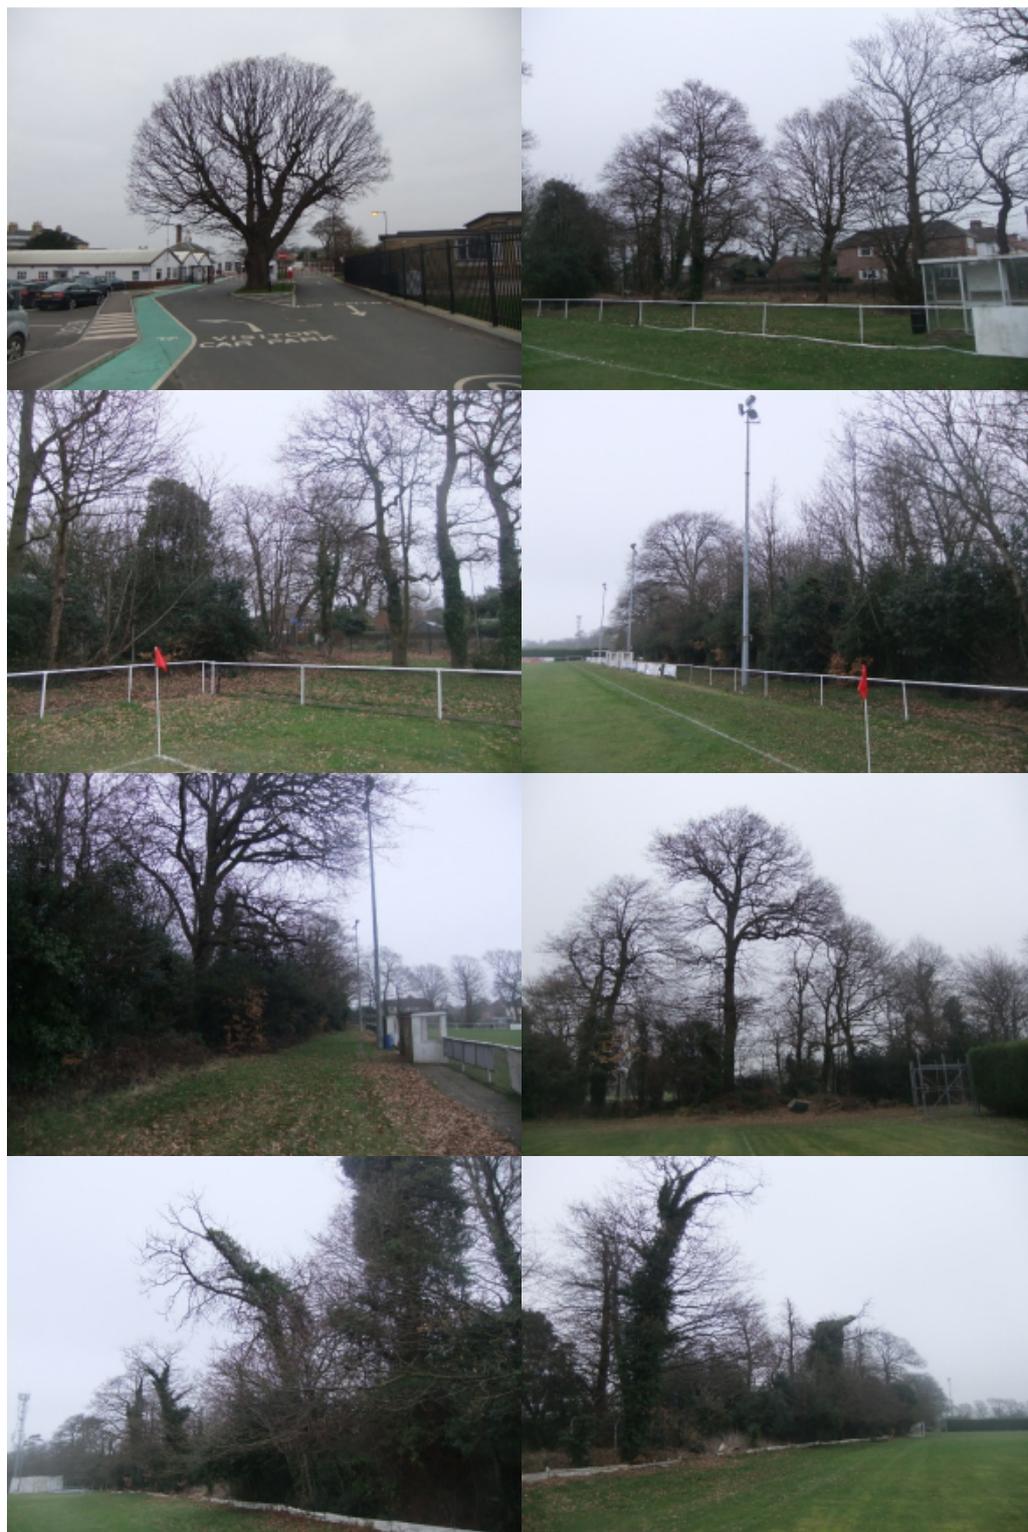
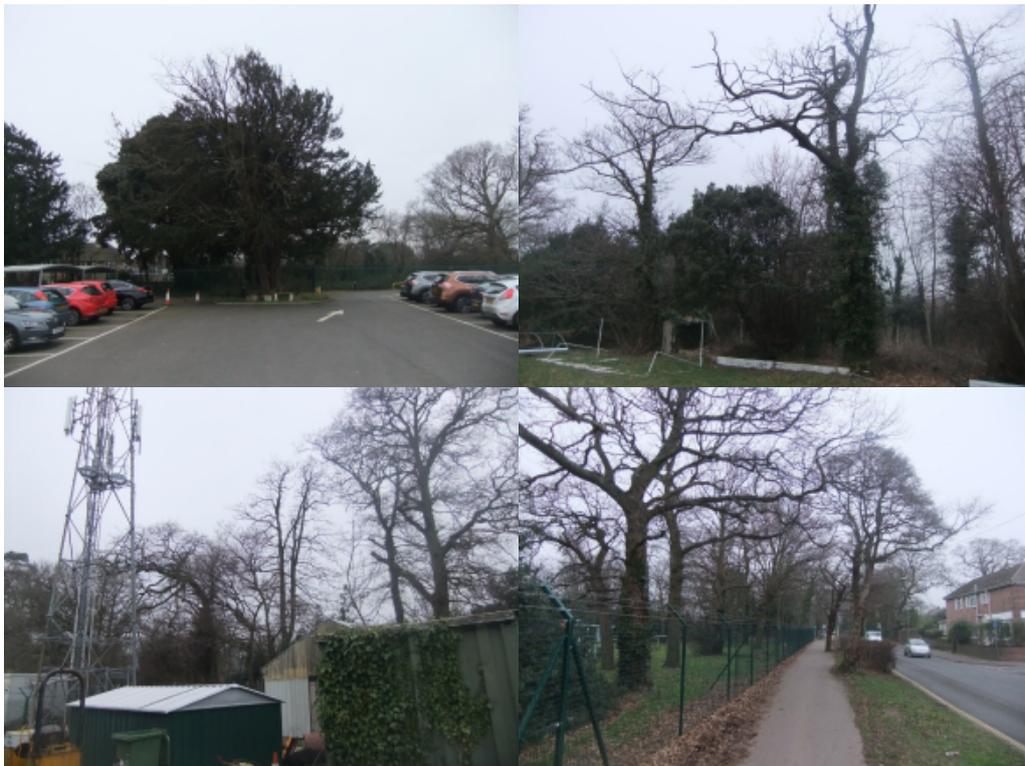
All photographs above are examples of trees or groups within the site
